Roofing in the Oasis Desert: Causes and Factors of Disappearance, “The Tidikelt Region as a Model”

Bouklila Fatima Zahra¹, Mezrag Mohamed²

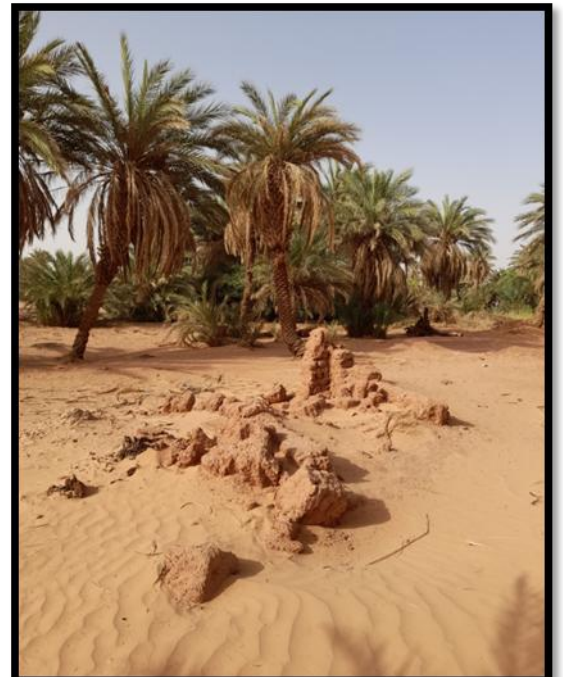
Figure No. 02: Selecting the Palm Tree for Use in Roofing

Wood is an essential material in the roofing process of residential facilities in the Tidikelt region, since palm wood is abundantly available. All the elements of its upper part are exploited and prepared for the roofing process of residential structures in the Tidikelt region; see Figures 01 and 02.

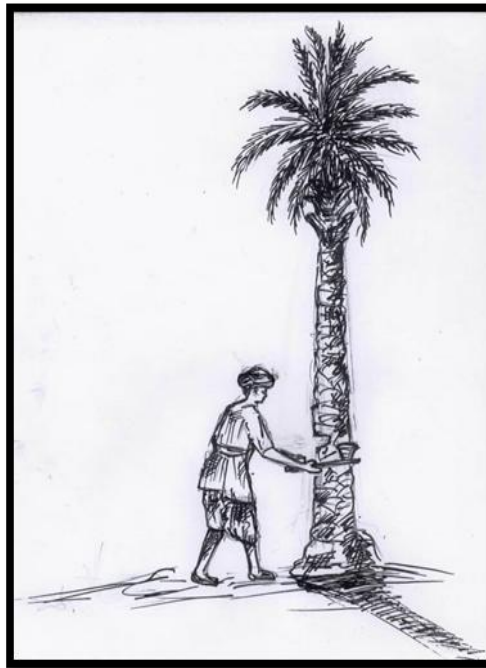
A- Cleaning process: The palm trunk is cleaned of the palm fronds and karanif attached to it, in addition to removing the fibers surrounding the trunk until the trunk becomes free of karanif, fronds, and even fibers. Thus, all the units are arranged separately: the trunks, then the karanif, then the fronds, and finally the fiber. All these operations are carried out while the palm tree is still standing and planted in the ground, because the fronds must be removed while green so that they can be straightened and dried, becoming dry, straight, strong, and solid. The same applies to the karanif and all the fibers, in order to benefit from their components, that is,

Figure No. 01: The Process of Cutting the Palm Tree

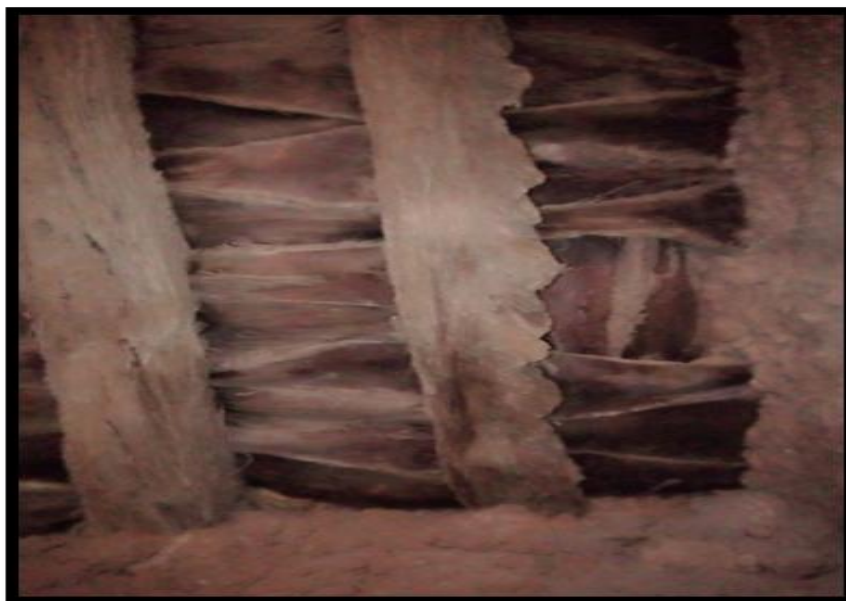
Figure No. 03: The Process of Roofing Using Wood and Palm Frond Bases

The roofing stage is considered one of the most important construction stages for covering houses, ksour, kasbahs, and some passageways in the Tidikelt region. Flat roofing was the most commonly used and widespread type in these desert areas. It was used because it was the most suitable and appropriate for the desert environment on the one hand, and because it was exploited for other benefits on the other hand. In summer, the rooftops are used for sleeping, drying clothes, and drying dates. The length of the palm wood branch controls the process of the

roofing of the walls of the rooms or passageways intended to be roofed or flattened. As Abd al-Rahman Ibn Khaldun pointed out⁸, a distance of about 20 cm is left between one trunk and another, so that the karanif are placed in an alternating manner over these trunks to cover the entire gap. This process continues until the whole room is completed, then fronds, fiber, and straw are placed as a lining for the karanif and to level the surface. Finally, clay mortar is poured over them in order to give solidity to the surface. See Figure No. 03.

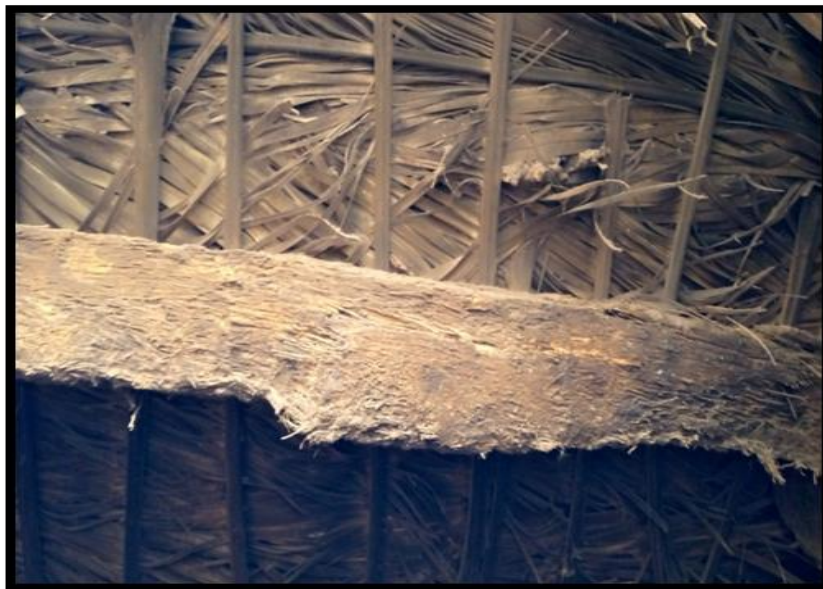
- **Heat:** Heat is considered one of the factors causing roof deterioration in adobe buildings in the Tidikelt region, and it plays an important role in the deterioration of wood. It is directly related to humidity, since when the temperature rises, humidity decreases, and whenever the temperature decreases, humidity in the wood increases. Heat affects the moisture content of the wood, causing the cells to dry out and shrink, which leads to cracks, twisting, and deformations. All of this occurs as a result of rising temperature and the passage of time. Thus, the cellulose nitrates deteriorate, the strength of the palm weakens, it becomes subject to thermal decomposition, and it loses its strength and rigidity. See Figure No. 04.

Figure No. 04: Representing the Drying and Breaking of Wood

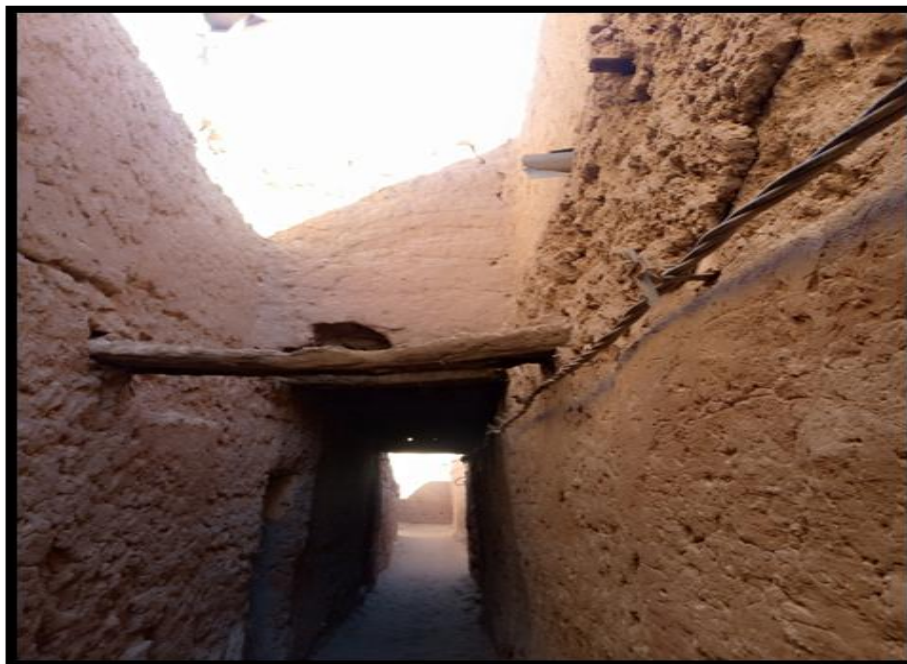
-Rain: The roof of earthen architecture is affected by rain, as heavy rainfall saturates the pores of the clay, giving it extra weight at the level of the building surface. The excess water drains through the gutter, yet some of it remains, forming small pools on the surface. This weight, resulting from the saturation of the clay pores on the one hand and the weight of the accumulated water on the other hand, causes great pressure on the roof. The wood and palm frond bases become unable to bear that weight, so one or two pieces of wood break. In this way, the roofing weakens, collapses, and falls. See Figure No. 05.

Figure No. 05: Showing the Collapse of the Wooden Beams of a Passageway Due to Rainfall

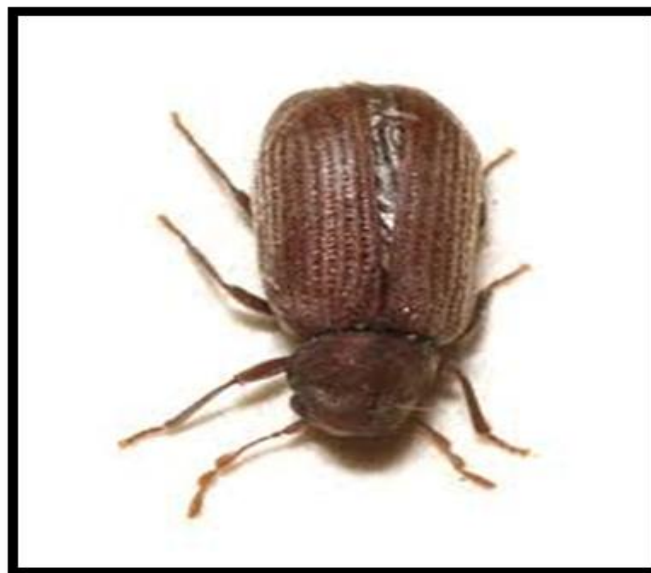
Figure No. 06: Represents an image of termites.

- **Decay:** The decay of the wood designated for roofing occurs due to woodworm, scientifically known as *Anobium*, which is a genus of beetles belonging to the family Anobiidae, and it has about seven species, of which 05 are extinct.¹³

This insect bores into the wood, creating holes and internal cavities within the timber, forming an empty cell inside it. This weakens the strength of the timber or the karnafa, and consequently reduces its resistance, causing the roofing to collapse at the weak point. As a result, one or two pieces of timber may break, along with the corroded karnafas between them. See Figure No 06

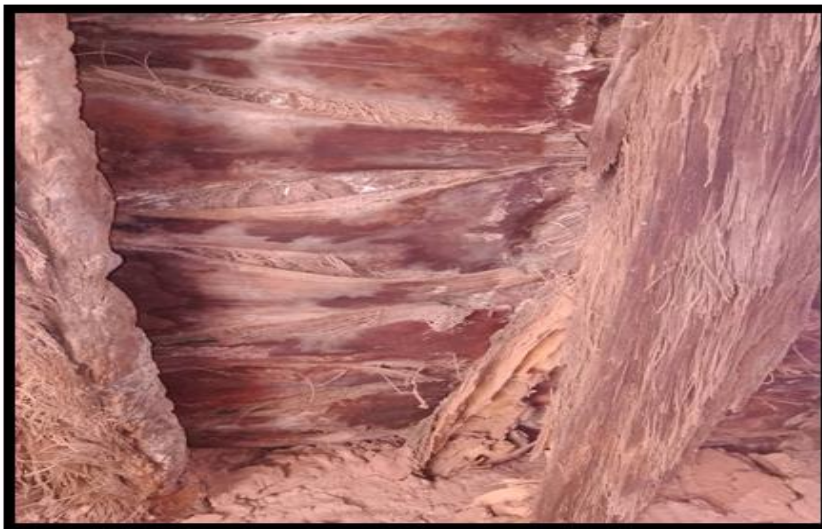
Termites attack the timbers and karanifs of roofing, causing clear brittleness in them. As a result, the timber can no longer withstand and bear the weight of the mortar, so it breaks and the decayed roof collapses. See Figures No. 07 and 08.

Figure No. 07: Represents termites. Figure No. 08: Represents wood damaged by termites.

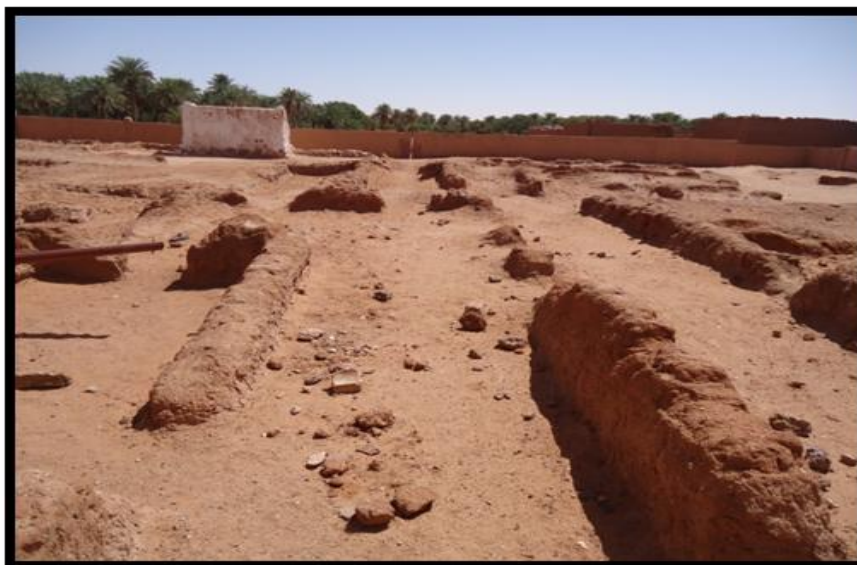
-Wars: Conflicts and wars do not only threaten human life, but also threaten property and archaeological and cultural acquisitions. Heritage is exposed to the danger of theft and looting, the worst of which is the total or partial destruction of these landmarks, and the best example of this is the Kasbah of al-Arab located in the Sebkhha district in the area of in Ghar, belonging to the eastern Tidikelt region, which was subjected to artillery shelling during French colonialism in the Battle of in Ghar on March 19, 1900. The kasbahs and houses were completely destroyed over the heads of the male and female mujahideen, who remain to this day beneath the rubble of this shelled kasbah. See Figure No. 09.

See Figure No. 09: The collapse of the Kasbah of al-Arab due to artillery shelling.
